A11103 737965

NBSIR 82-2465 (A)

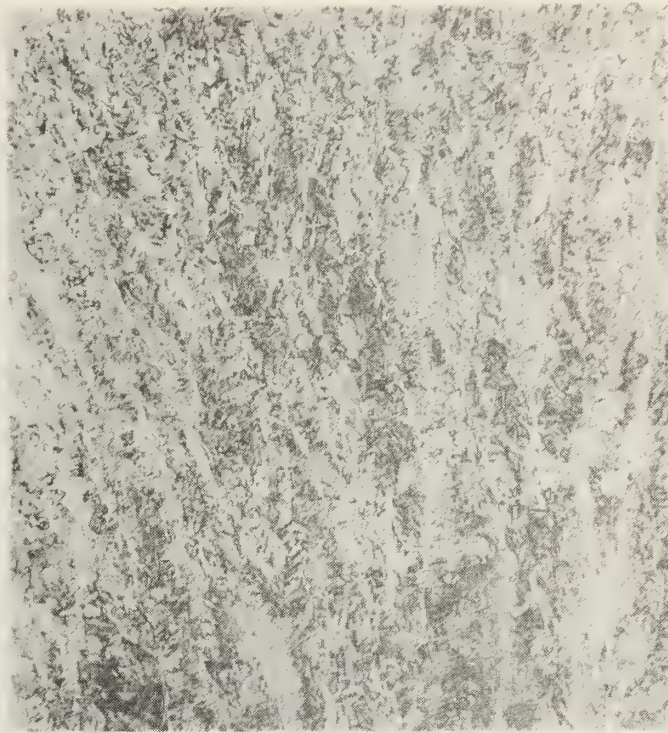
Figure A7.4.1-3 Microstructure representative of the weld metal in transverse section through NBS weldment IC. The microstructure appears to consist primarily of bainite. Etchant: two percent nital. X200

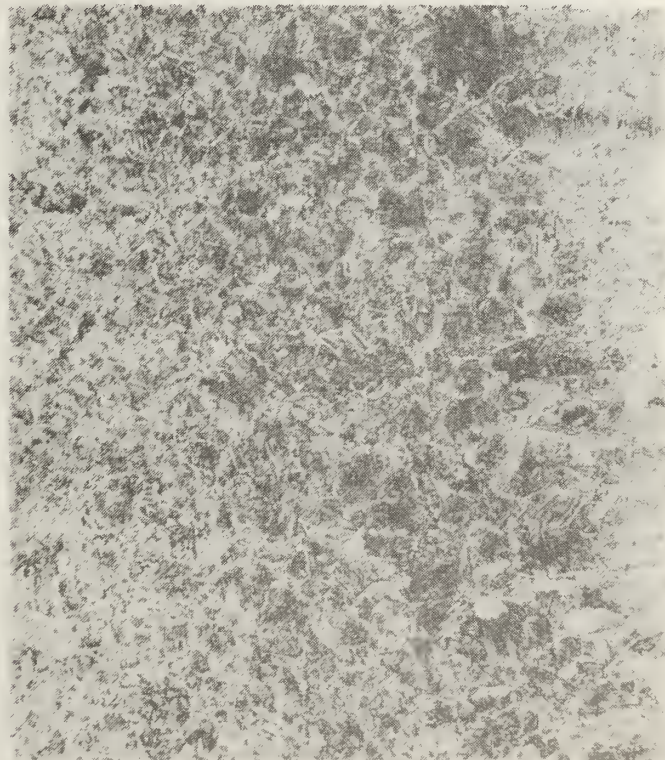
Figure A7.4.1-4 Transition region from weld metal (right) to heat affected zone (left) in transverse section through NBS weldment IC. Etchant: two percent nital. X200

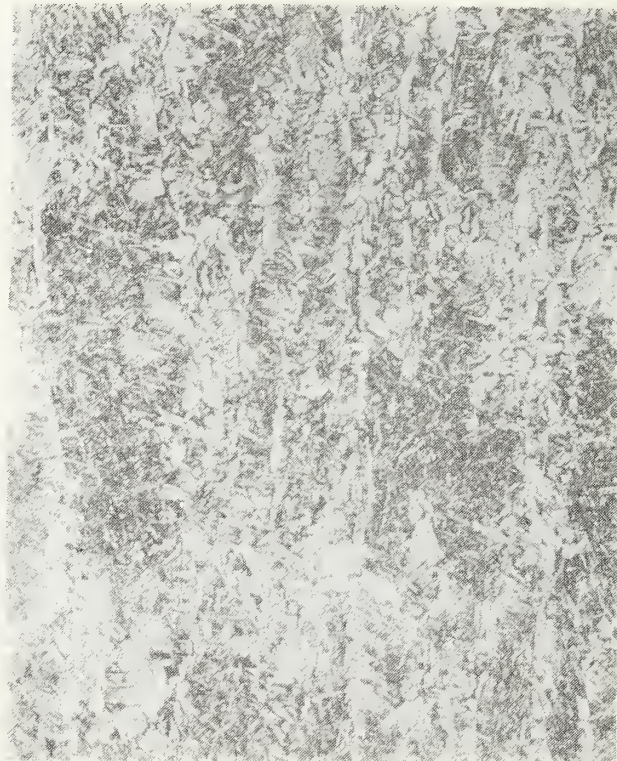
Figure A7.4.1-13 Representative microstructure of the weld metal in transverse section 1BM2 through box beam 9U (NBS 1). The microstructure consists primarily of bainite. Etchant: two percent nital. X200

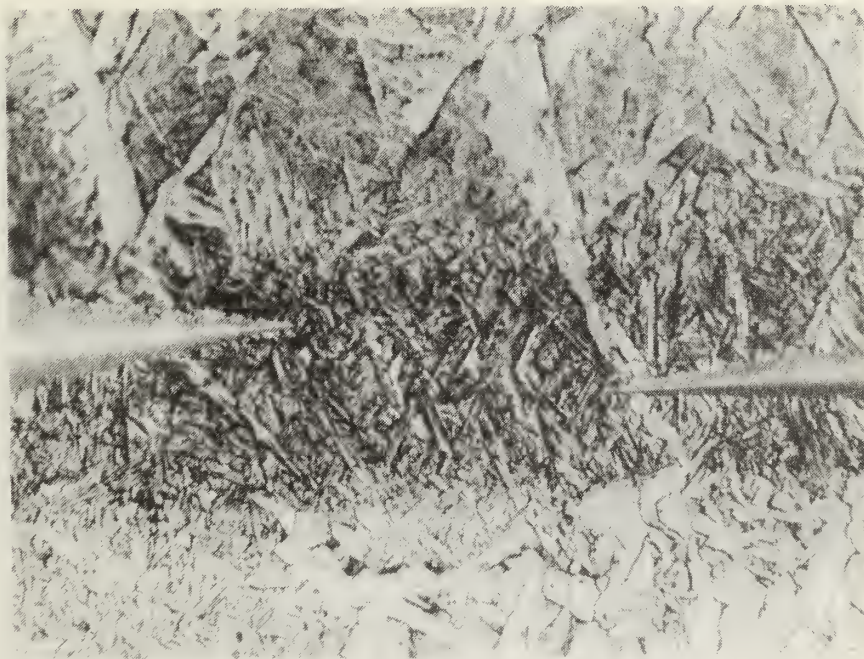
Figure A7.4.1-15 Hard area similar to that shown above, but at higher magnification. The hard area is in the center running from side to side. The microstructure appears to consist of fine grained tempered martensite. Parts of two hardness impressions can be seen at either side of the figure. Etchant: two percent nital. X800

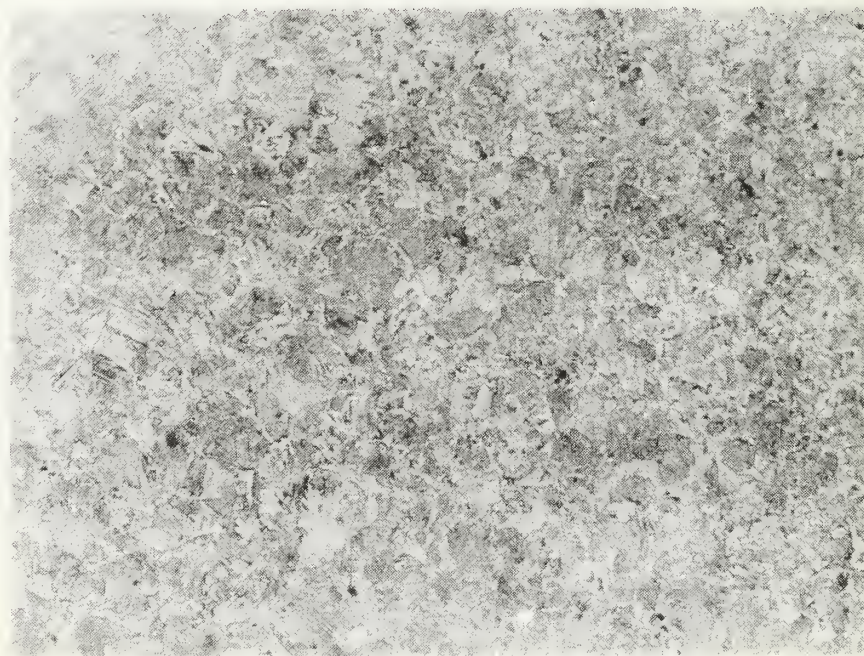
Figure A7.4.1-17 Region representative of the heat affected zone in section 1BM1. The microstructure appears to consist of ferrite, both as a network in prior austenite grains and as needles, bainite, partially spheroidized carbides, and tempered martensite. Etchant: two percent nital. X200

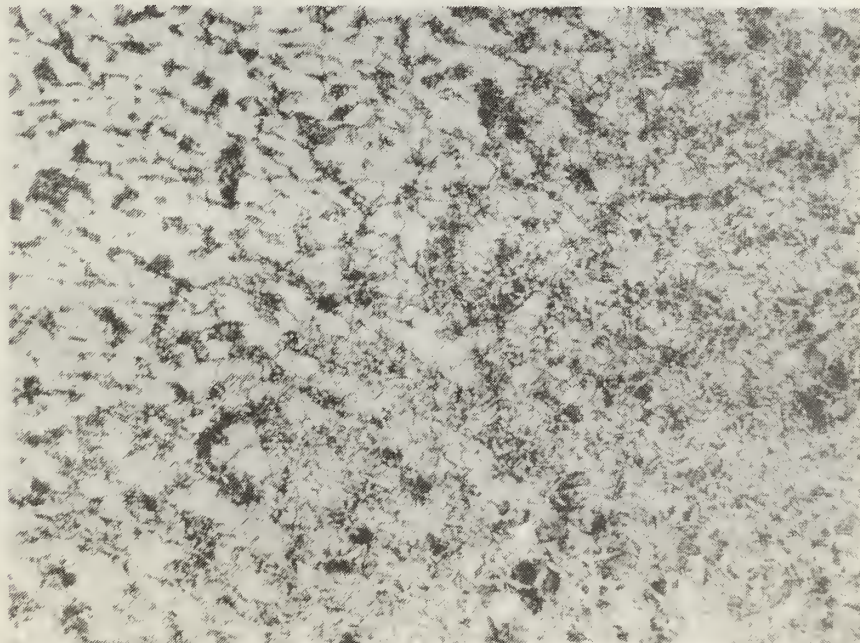
Figure A7.4.1-19 Transition from heat affected zone (right) to base channel material (left) in section 1BM2. Etchant: two percent nital. X200

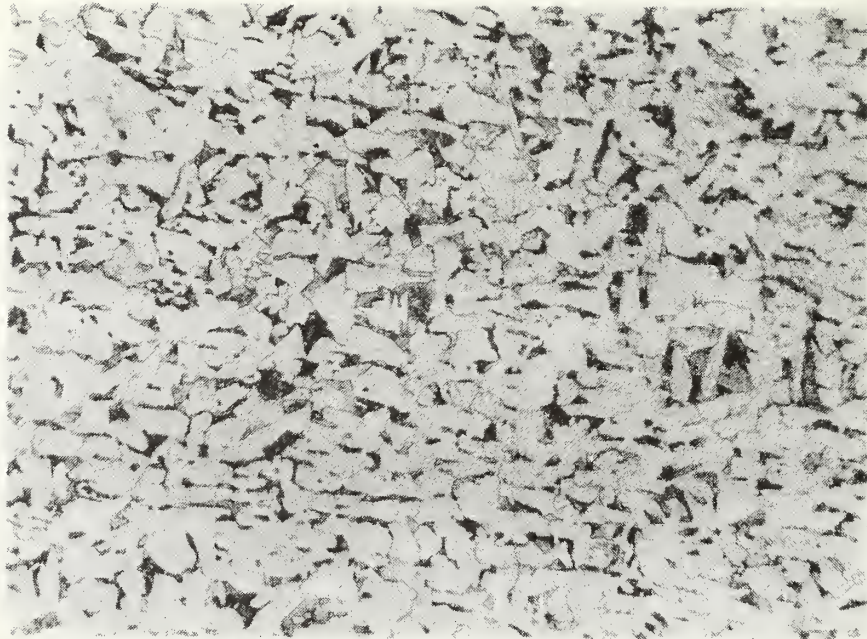
Figure A7.4.1-20 Region representative of base channel material in section 1BM1. The microstructure consists primarily of ferrite (light) and pearlite (dark) in the normalized condition. Etchant: two percent nital. X200

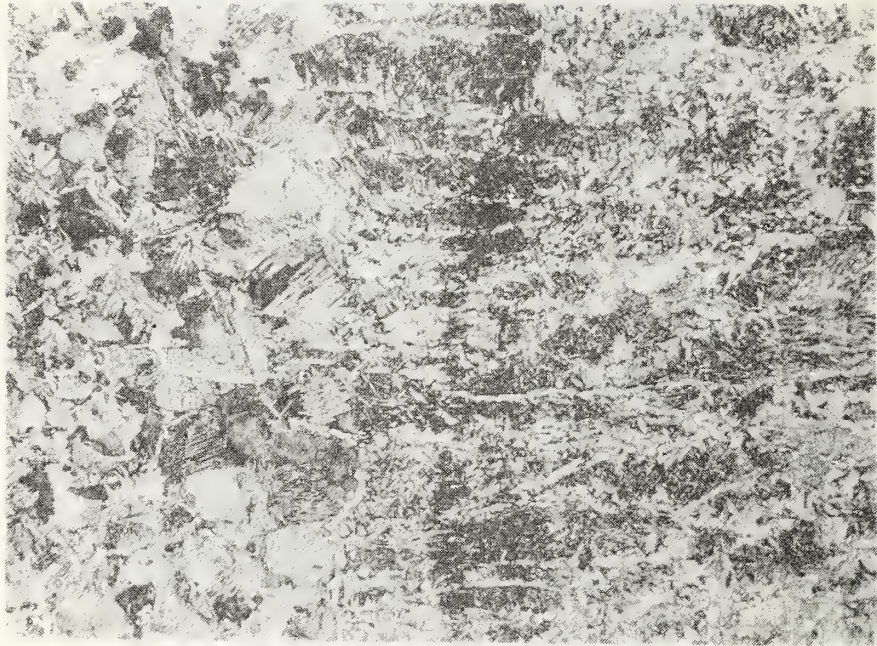
Figure A7.4.1-27 Transition zone from weld metal (right) to heat affected zone (left) in section 2BM1. Etchant: two percent nital. X200

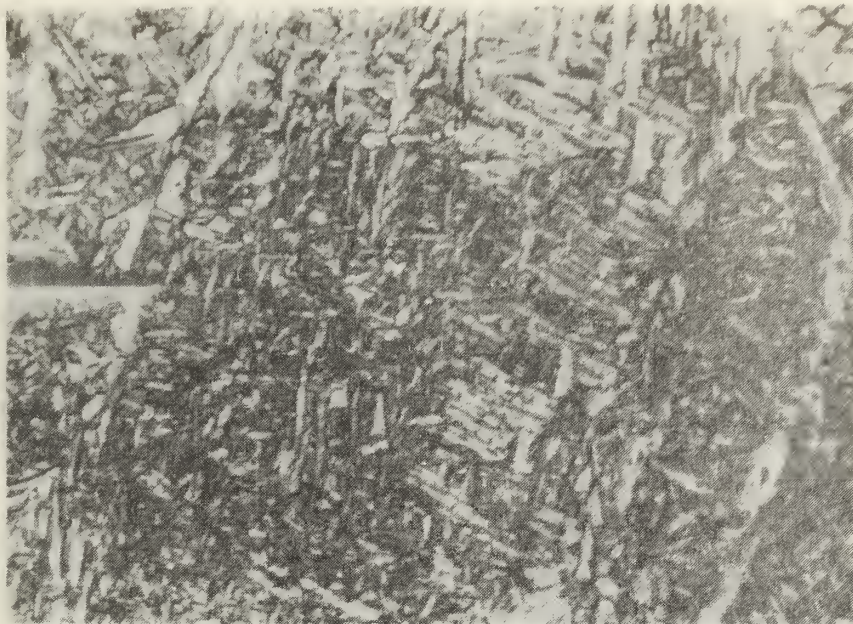
Figure A7.4.1-29 Region of the transition zone from weld metal to the heat affected zone in section 2BM2. This region is one of the hard areas. The microstructure appears to consist of tempered martensite. Part of a hardness test impression can be seen at the left center. Etchant: two percent nital. X1200

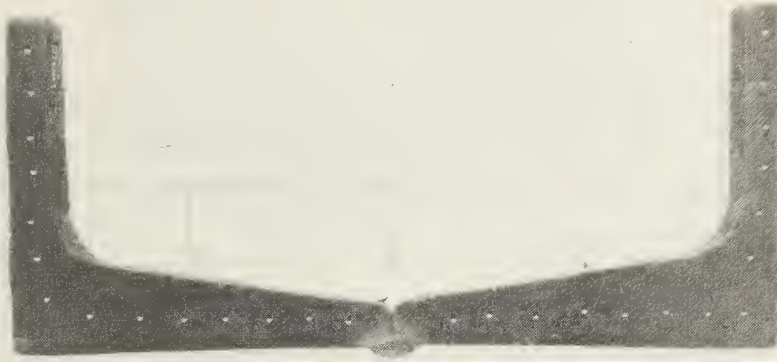
Figure A7.4.1-33 Transverse section 3Bm1 through the bottom of walkway box beam 9M (NBS 3). The south channel of the box beam is to the left and the north channel is to the right. The weld connecting the flanges of the two channels used to fabricate the box beam is in the center. Parts of the web regions of each channel had been removed before this photograph was taken. The indentations appearing on the surface of the section are the result of hardness measurements. Etchant: two percent nital. ~X1

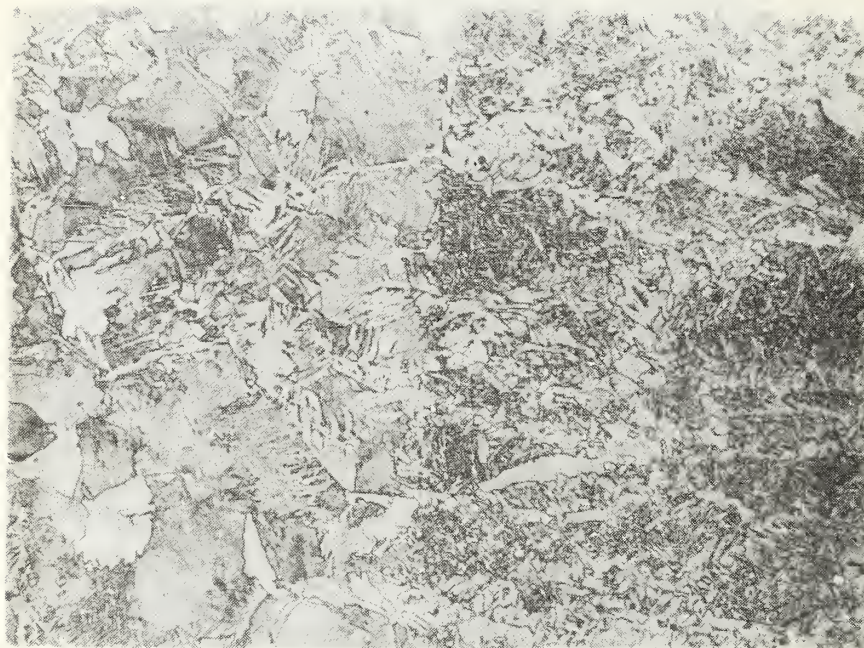
Figure A7.4.1-39 Transition zone from weld metal (right) to heat affected zone (left) in section 3BM2. Some inclusions can be seen primarily in the weld metal. Etchant: two percent nital. X200

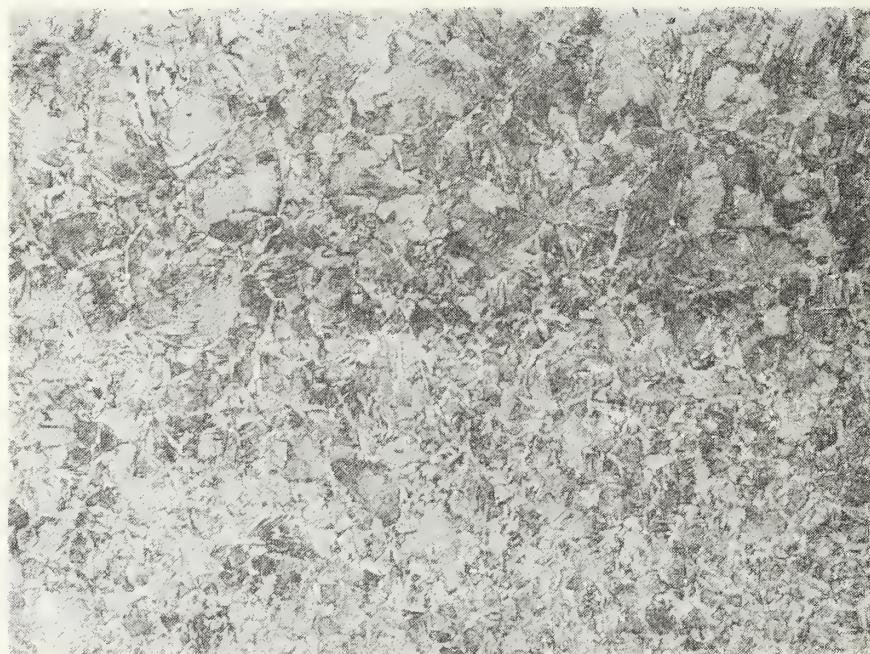
Figure A7.4.1-40 Region representative of the heat affected zone in section 3BM1. The microstructure appears to consist of ferrite both as a network in prior austenite grain boundaries and as needles, bainite, partially spheroidized carbides, and tempered martensite. Etchant: two percent nital. X200

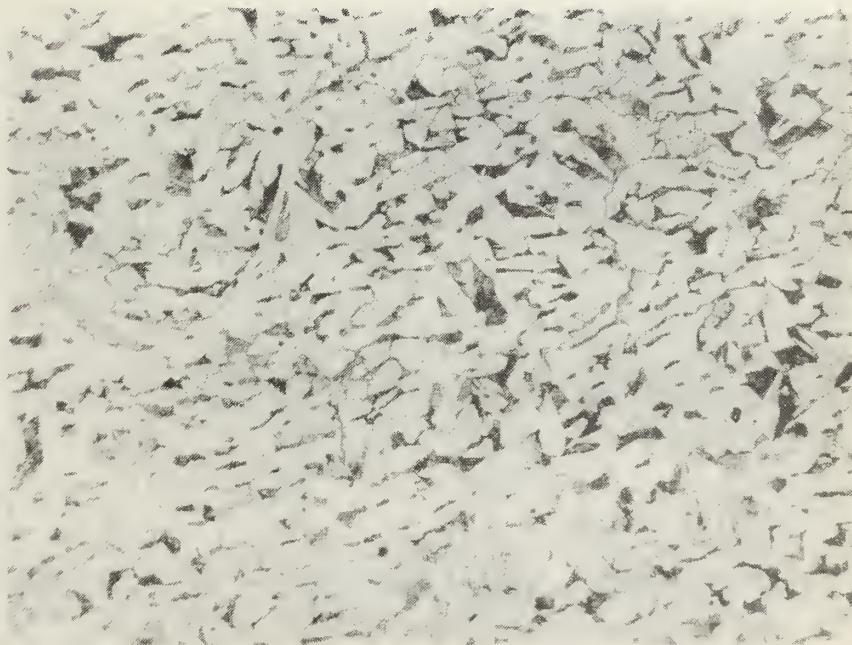
Figure A7.4.1-42 Representative region of base channel material in section 3BM1. The microstructure consists of ferrite (light) and pearlite (dark) in the normalized condition. Etchant: two percent nital. X200

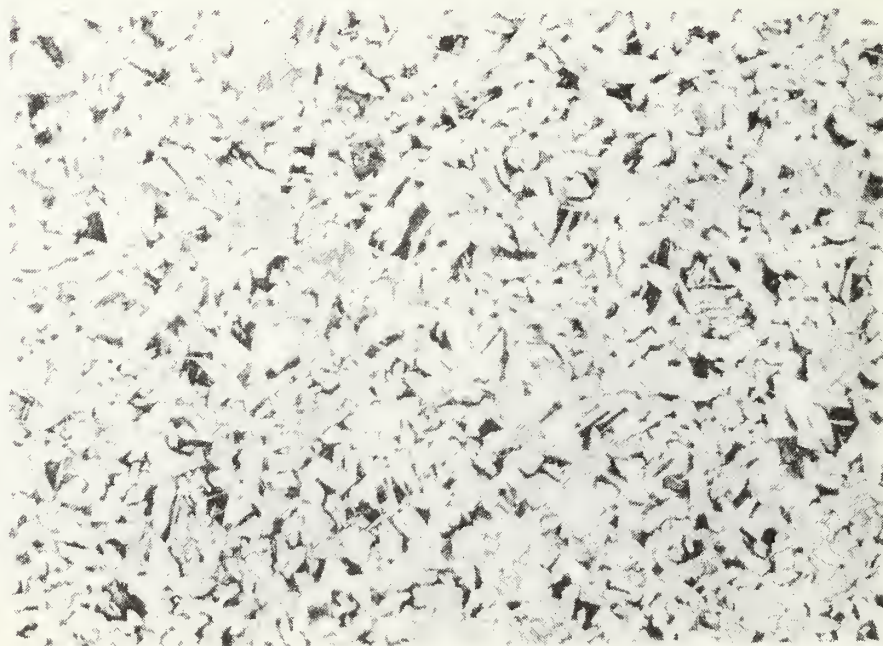
Figure A7.4.2-2 Transverse section through hanger rod NBS 5B showing the representative microstructure. The microstructure consists of ferrite (light) and pearlite (dark) in a normalized condition. Etchant: two percent nital. X100

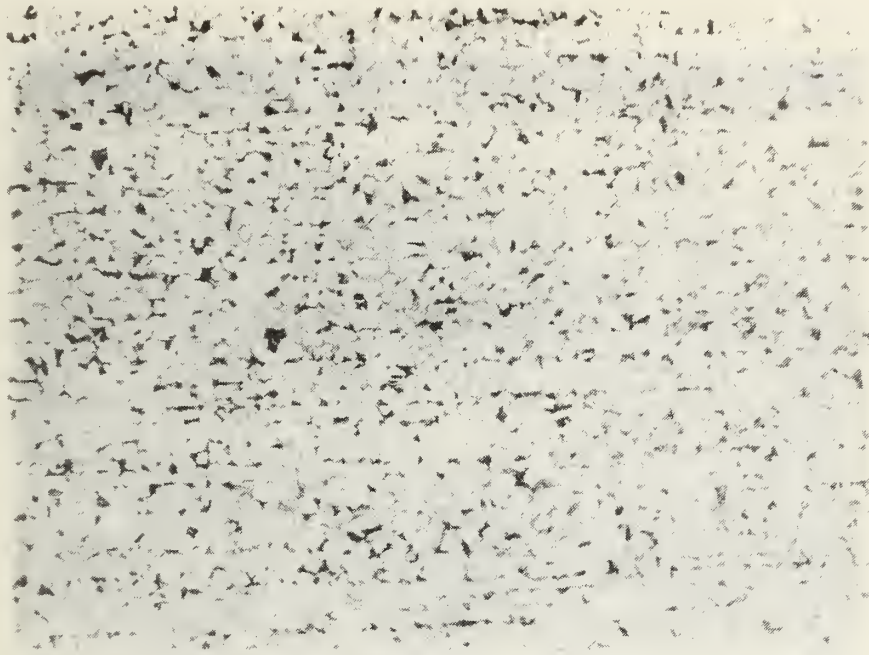
Figure A7.4.2-3 Longitudinal section through hanger rod NBS 5A showing the normalized microstructure consisting of ferrite and pearlite. Etchant: two percent nital. X100

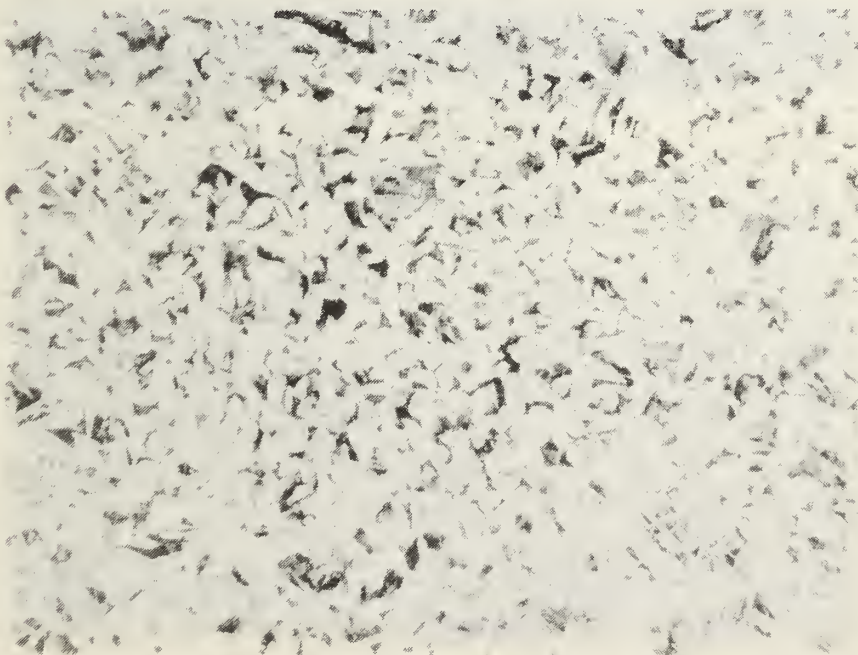
Figure A7.4.2-4 Longitudinal section through hanger rod NBS 5B showing the normalized microstructure consisting of ferrite and pearlite. Etchant: two percent nital. X100
